AIRCRAFT ACCIDENT INVESTIGATION BUREAU

INVESTIGATION REPORT ON

ACCIDENT TO THE B737-MAX8 REG. ET-AVJ OPERATED

Report No. AI-01/19
Pub, Date December 23, 2022

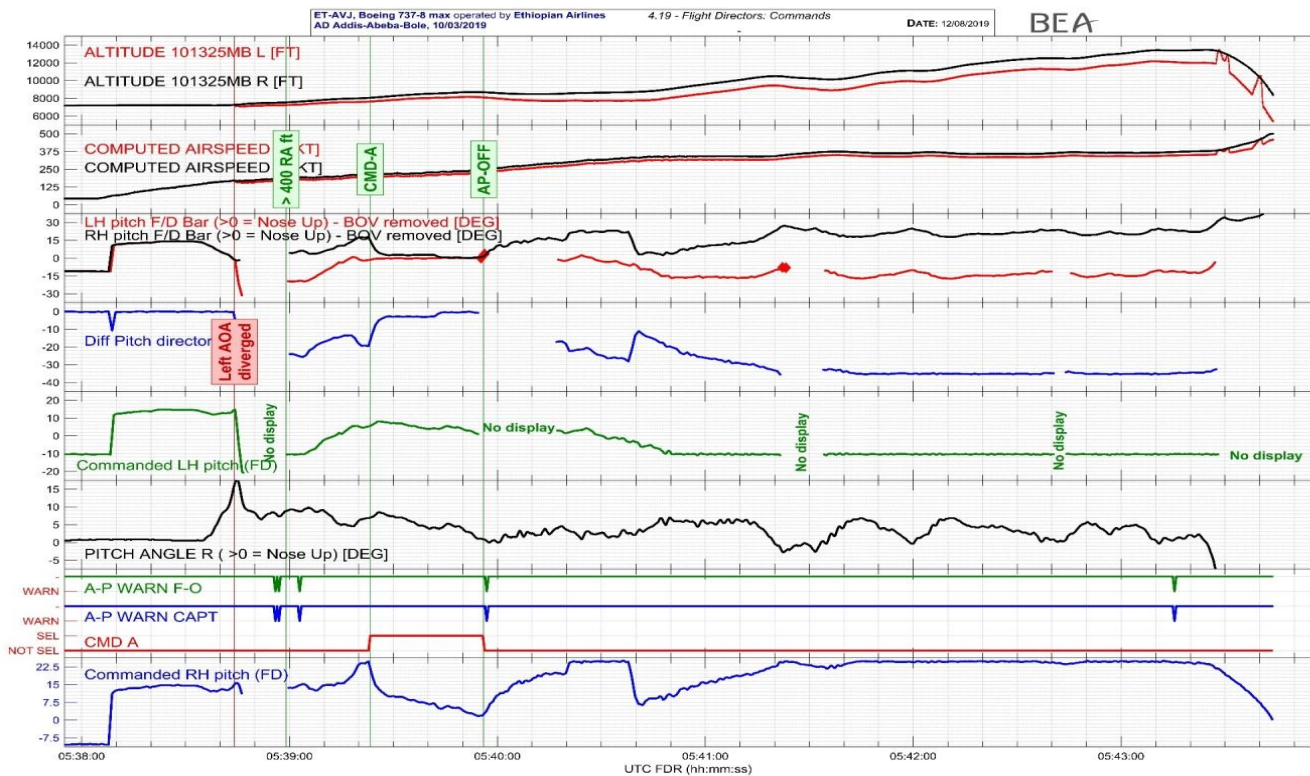
FIGURE82: PITCH F/D COMMANDS

- The F/D was in speed mode.
- The Airplane should have been climbing but the computed vertical speed value of the Airplane had been lower than the Climb threshold for 5 consecutive seconds.
- At the LH side the Airplane approached to stall
- LH F/D pitch commands (A/P not engaged)

Note: No anomalies were observed in the RH pitch F/D bar positions the RH pitch F/D bar positions are then considered as valid positions based the Airplane attitude, altitude, and speed engaged modes. Except under the autopilot, the LH pitch F/D bar position was at least 10° lower than the RH pitch F/D bar. The commands provided by the LH pitch F/D bar were not consistent with the true Airplane status and the engaged modes, due to the effects of the erroneous AOA on the calculation of the minimum operation speed.

- Each time the LH pitch F/D bar automatically reappeared, without any crew action. The underlying cause of the anomalous LH pitch F/D behavior was confirmed to be erroneous LH AOA sensor values. Erroneous AOA results in display of the IAS DISAGREE and ALT DISAGREE alerts. The appropriate NNC for these alerts is the Airspeed Unreliable NNC, which, as a memory item, requires that the crew turn off both flight directors.

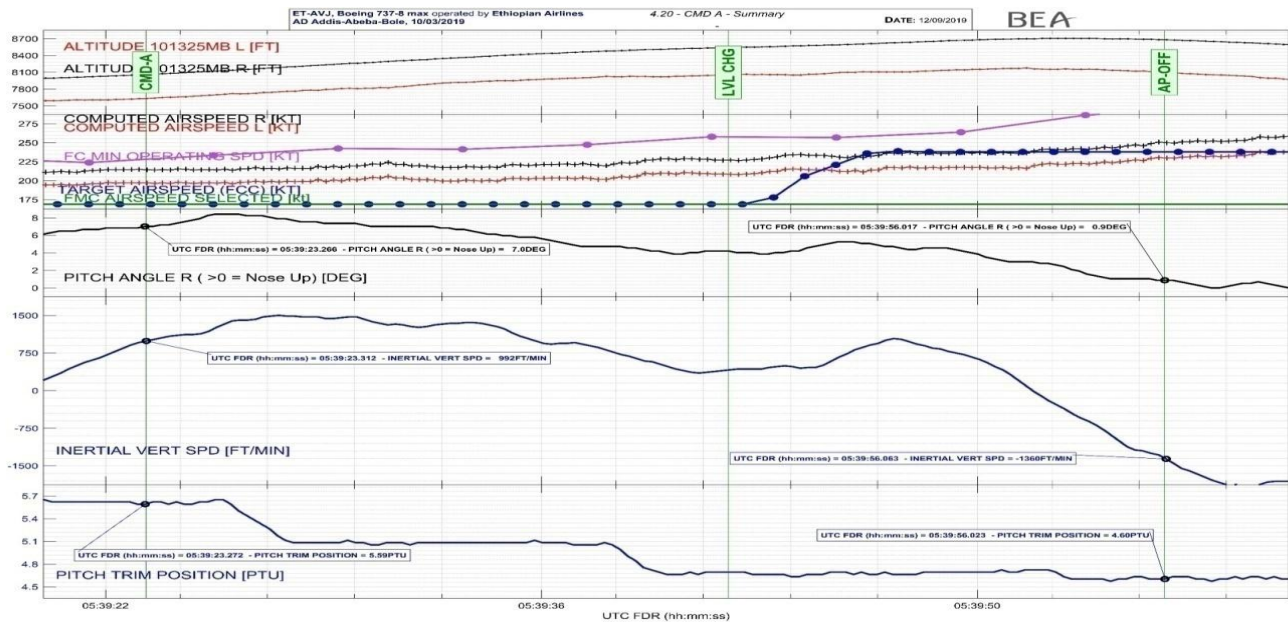
FIGURE85: CMD A - SUMMARY

At the connection of CMD A, the Airplane was climbing with a vertical speed of around 1,000 ft/min increasing, a pitch value of around 7° increasing and a stabilizer position of 5.6 units.

When CMD A automatically disconnected, the Airplane was descending with a vertical speed of around -1,400 ft/min, a pitch angle of around 1° and a stabilizer position of 4.6 units.

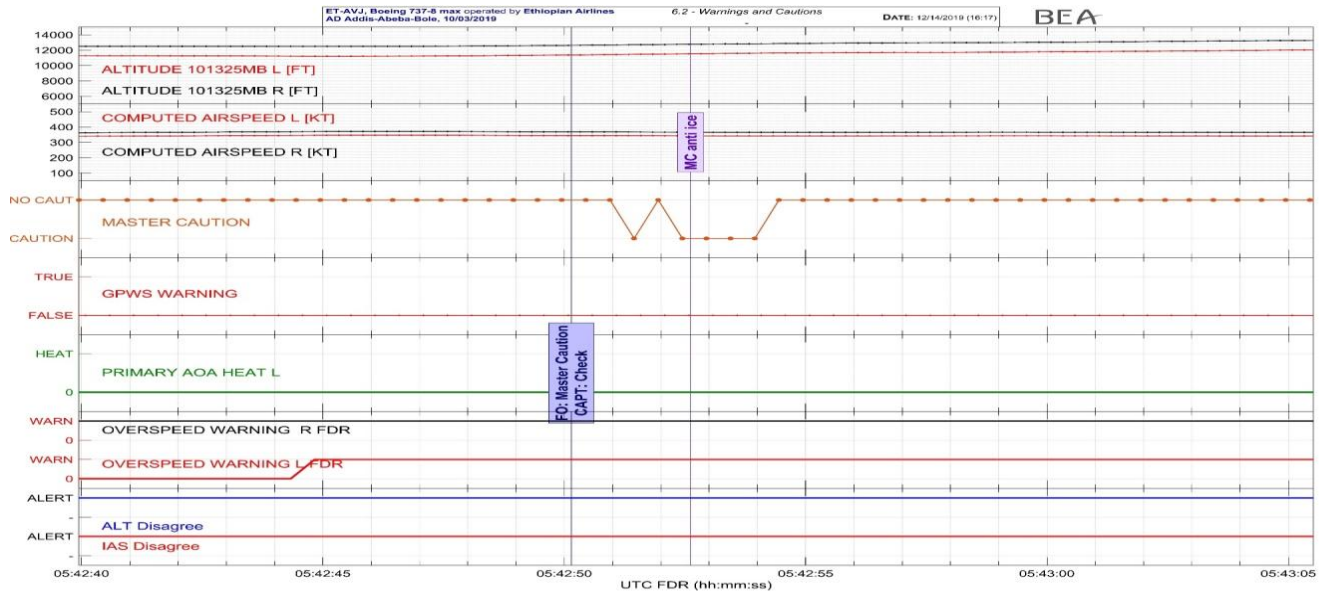
FIGURE 89: MASTER CAUTION RECALL

The first master caution triggered at 5 h 38 min 48 s during 7s. The reason for this master caution was anti-ice left alpha vane. This caution is triggered when low current is sensed in the AOA vane internal heater circuit. At 5 h 42 min 47 s, the crew exchanged about the master caution.

Then master caution triggered a second time at 5 h 42 min 51 s during 2.5 s. The crew detected: “Master Caution/anti Ice/left Alpha Vane”.

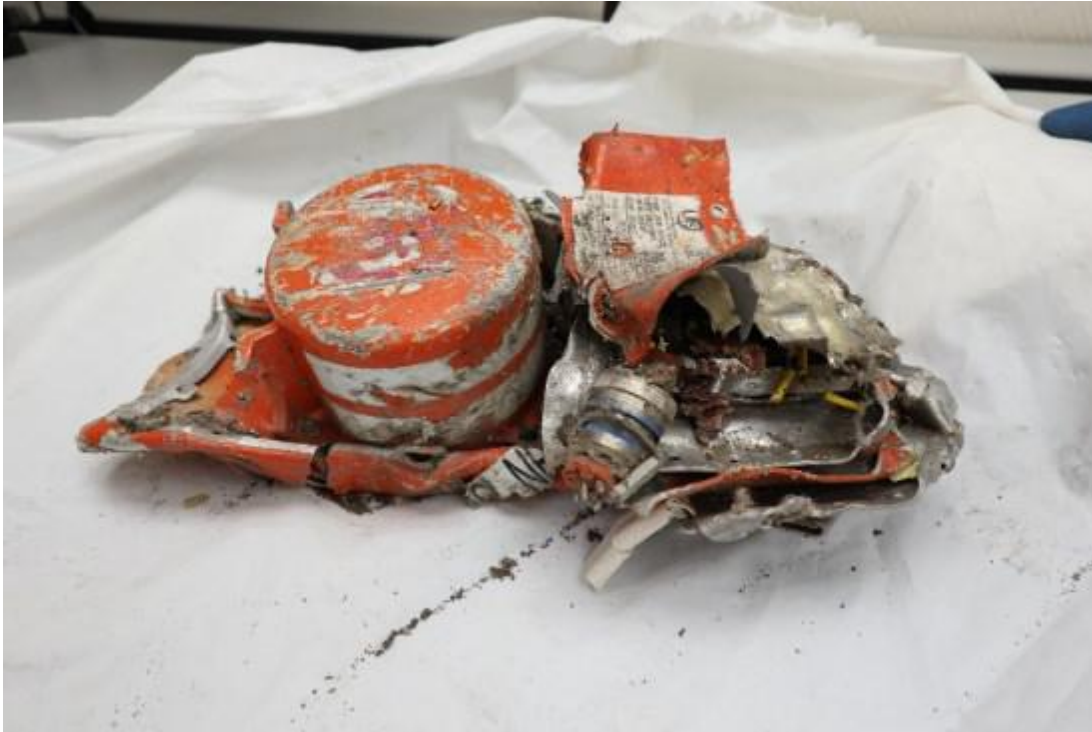
FIGURE 1: FDR FOUND IN THE SUITCASE BROUGHT BY ETHIOPIAN EAIB

The FDR was first visually examined. The chassis was damaged and folded on itself. The acquisition boards were visible as well as some internal connectors. The protected module Crash Survival Module Unit (CSMU) was still attached to the chassis and presented scratches. There was no ULB attached to the CSMU. A recorder identification plate was found close to the CSMU on the chassis, but not fixed to the chassis, on which the following numbers were written: P/N 2100-4945-22, S/N 001217995

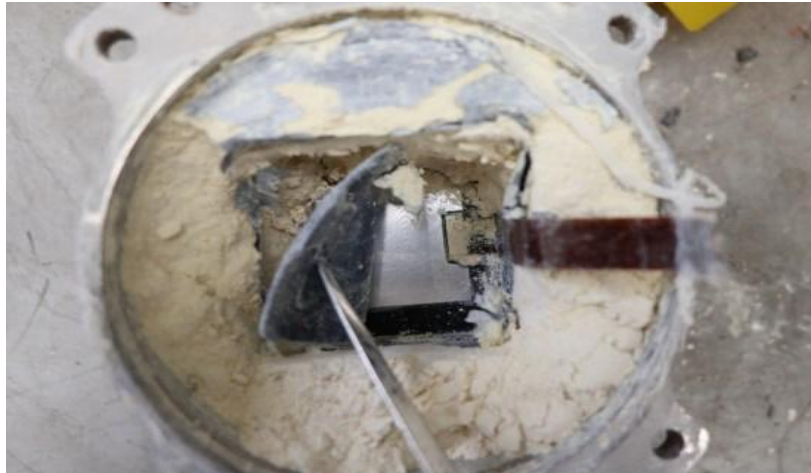
FIGURE 2: AT OPENING THE FDR CSMU, SHOWING THE MEMORY PUCK AND FLEX

The cover of the CSMU was unscrewed. The insulation material inside the CSMU was no longer compact and it was scooped out to access the memory puck.

It was first attempted to extract the memory puck by gently pulling on the flex. It was found that the connector was not properly attached to the memory puck.

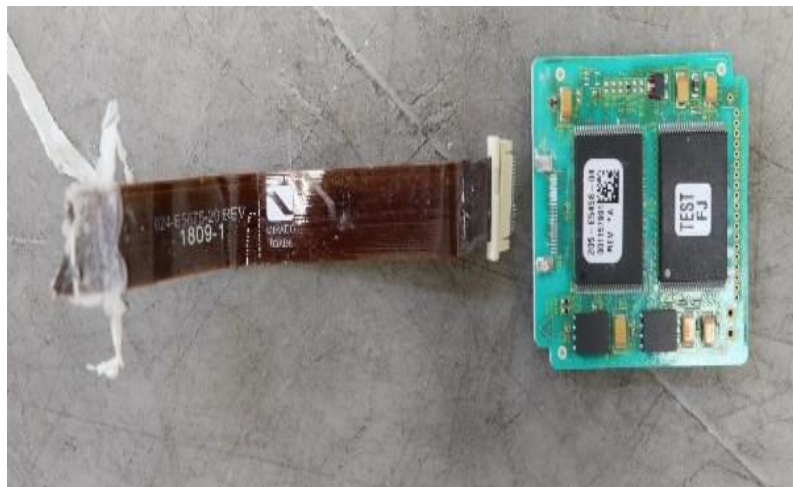
FIGURE3: FDR MEMORY BOARD, FLEX AND CONNECTOR

The memory puck was opened and the electronic board containing the memory component support was extracted. The memory board identification was P/N 205-E5458-04, S/N 001157901 and the flex identification was 024-E5675-20 REV, 1809-1.

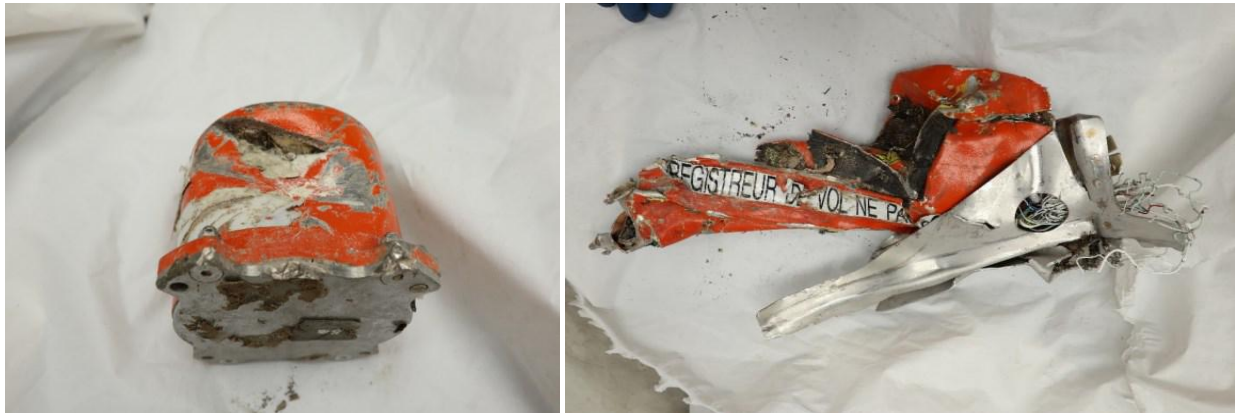
FIGURE 8 CVR CSMU AND CHASSIS WHEN BROUGHT BY ETHIOPIAN EAIB

The CVR CSMU was already separated from its chassis when it was brought to the BEA facilities. There was no ULB attached to it and no identification plate was found on the CSMU.

The isolated chassis was damaged and still partially attached to the Airplane rack on which it was mounted. There was no identification plate on it. Wires were visible on the back side.

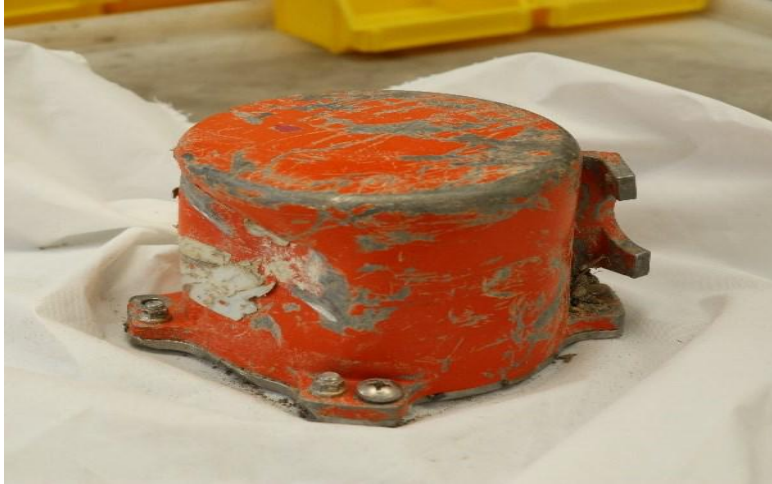
FIGURE 9: CVR WHEN OPENING THE SUITCASE BROUGHT BY ETHIOPIAN EAIB

The CSMU case showed an opening. The hole on the side opposite to the ULB fixation allowed seeing the internal insulation material

The interface board that is supposed to be located under the CSMU was missing and the flex connecting it to the memory puck was damaged.

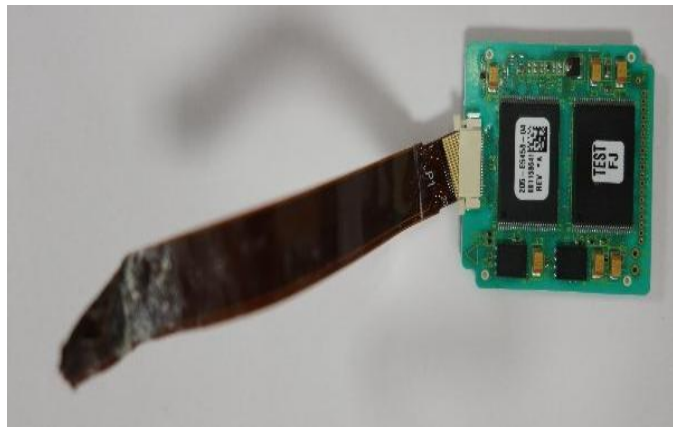
FIGURE 10: CVR MEMORY BOARD AND FLEX

The CVR memory board and flex were visually inspected with the Keyence microscope. There was no damage on the board and the connector was in good condition.

A second observation with the X-ray was made, which confirmed that the connector soldering were in good condition.
